Challenge

An impeller required unscheduled cleaning from the copper chromite (catalyst) buildup every three months.

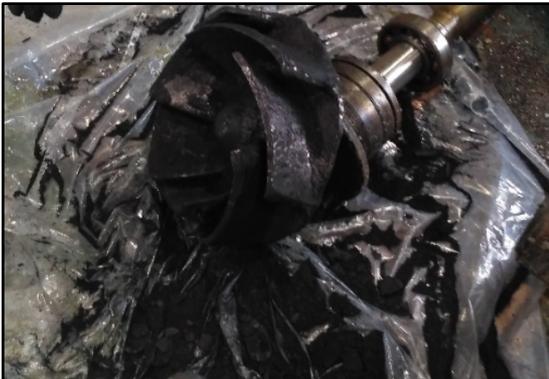
Buildup of catalyst in the impeller caused the motor to overload.

Catalyst built up in the Impeller: needle gun cleaning was required.

- Hot water pressure wash.
- Grit blast to Sa 2.5 with 3 mil (75 µm) angular profile.

- Three coats **ARC HT-S** to DFT (0.9 – 1.2 mm) on impeller, internal pump casing, and backplate.
- Dynamic balancing of the impeller.

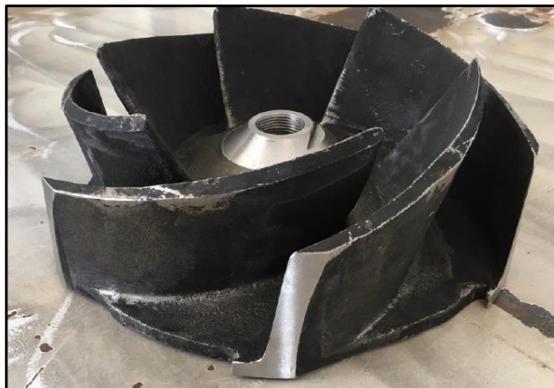
Condition of new impeller, before grit blast.

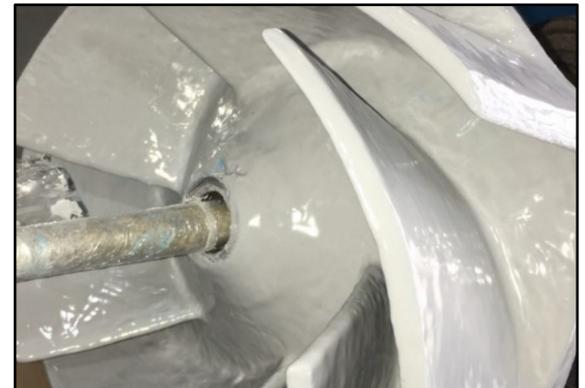
Final coat of ARC HT-S.

MTBR extended over eight months with inspection only 15% final coat loss.

The built up catalyst was easily cleaned by using a water pressure wash. Previously, needle gun was required to remove the buildup.
